BioPoly® Great Toe Case Report

Resurfacing of the 1st Metatarsal Head with the BioPoly Great Toe Hemiarthroplasty Implant: A Case Report

Steven Herbst, MD – Central Indiana Orthopedics, Muncie, Indiana

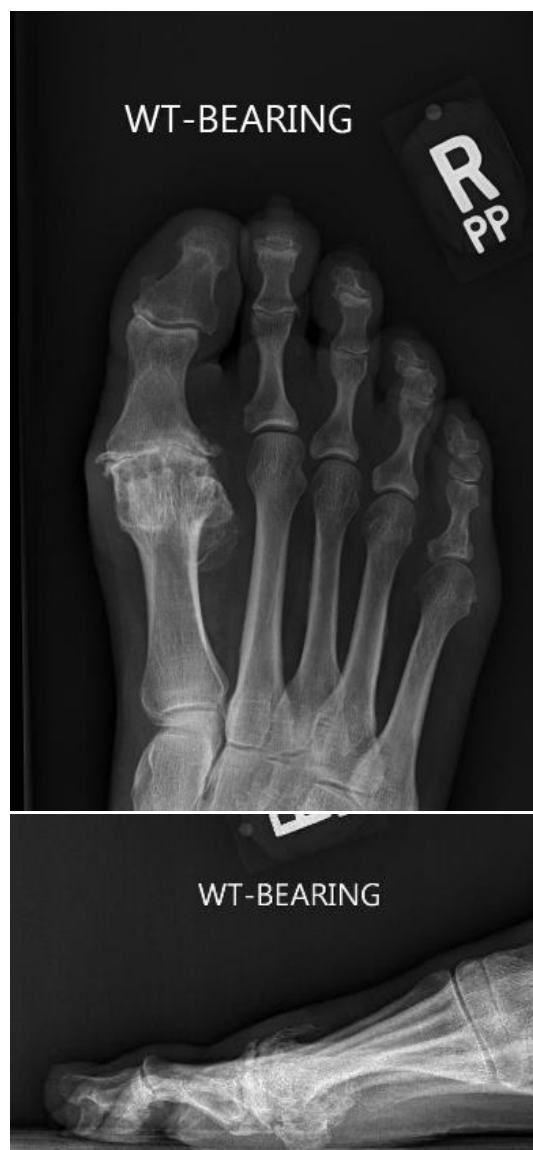
Diagnostic Imaging revealed a Grade 4 hallux rigidus condition (Figure 1). The patient was initially managed with shoe wear modifications and an intra-articular corticosteroid injection. The patient was able to tolerate symptoms with over-the-counter medications for approximately three years after the initial consultation. She then presented back to the Clinic with worsening symptoms and a desire to proceed surgically.

Figure 1: Pre-Operative Xray

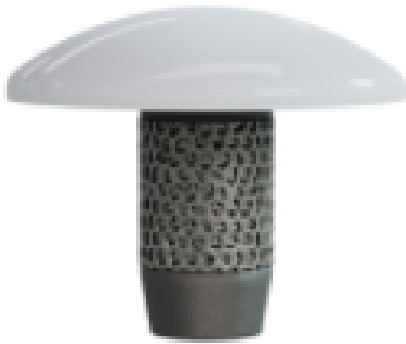
A detailed surgical discussion was completed. She was offered hallux mtp arthrodesis or a BioPoly hallux MTP implant (Figure 2). The BioPoly Great Toe is a hemiarthroplasty implant that contains a unique material (BioPoly) that combines a common plastic for implants (UHMWPE), with a lubricating molecule (Hyaluronic Acid) native to the joint. This material is compression molded to a porous titanium stem.

Figure 2: BioPoly Hallux MTP implant

The implant used to treat this patient incorporates the joint lubricant hyaluronan into compression molded UHMWPE. The hyaluronic acid incorporated in the implant results in a very biocompatible and cartilage friendly material that allow surrounding and opposing cartilage to be preserved. That combined with the minimal bone resection and an available porous titanium stem allow for stable implantation minimizing risks of subsidence and loosening.

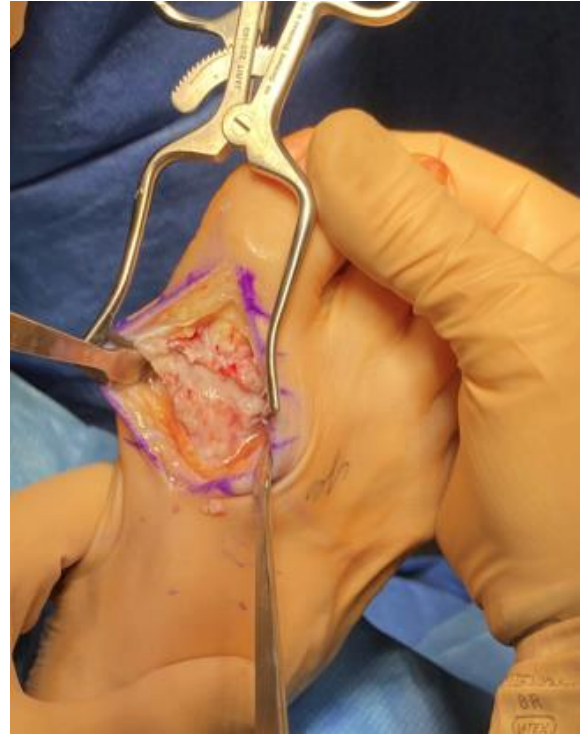
The joint was opened with a standard dorsal arthrotomy (Figure 3).

Figure 3: Initial Joint Exposure

The EHL was identified and protected. The capsule was released sharply off of the joint dorsally medially and laterally. There were Grade 4 changes to both sides of the joint with significant osteophyte formation.

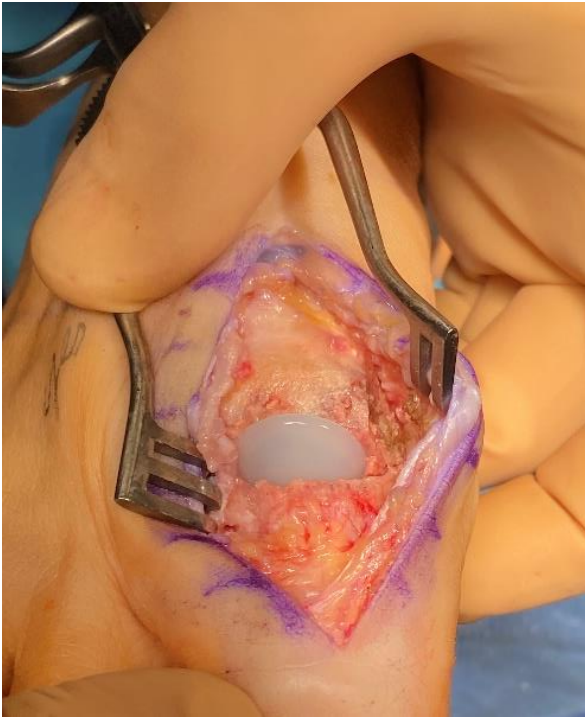
To expose the joint fully, osteophyte off of the metatarsal head and proximal phalanx was removed. The MTP joint was hyper plantar flexed. A 4 mm resection of the metatarsal head perpendicular to the long axis of the first metatarsal was completed. The sizing instruments revealed a size 18 to be a best fit for the metatarsal. The sizing paddle was then used to place a guide pin centrally within the longitudinal aspect of the metatarsal. The reamer was utilized over the guide pin and the trial implant was placed. The trial fit well and was replaced with the final implant. The implant had excellent press fit.

Figure 4: Press fit implant after osteophyte resection.

Additional osteophyte was resected (Figure 4). Fluoroscans images were obtained (Figure 5). Intraoperative range of motion was 10 degrees of plantar flexion and 60 degrees of dorsiflexion. the capsule was closed with 3-0 Vicryl, subcutaneous tissues with 3-0 vicryl, and skin with staples.

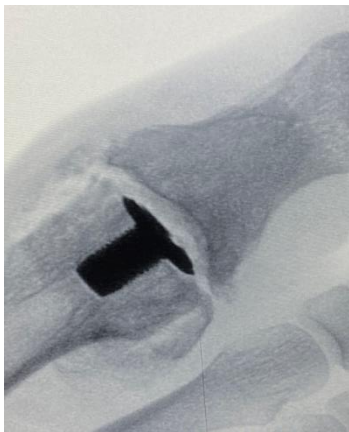
Figure 5: Intraoperative Fluoroscans Image

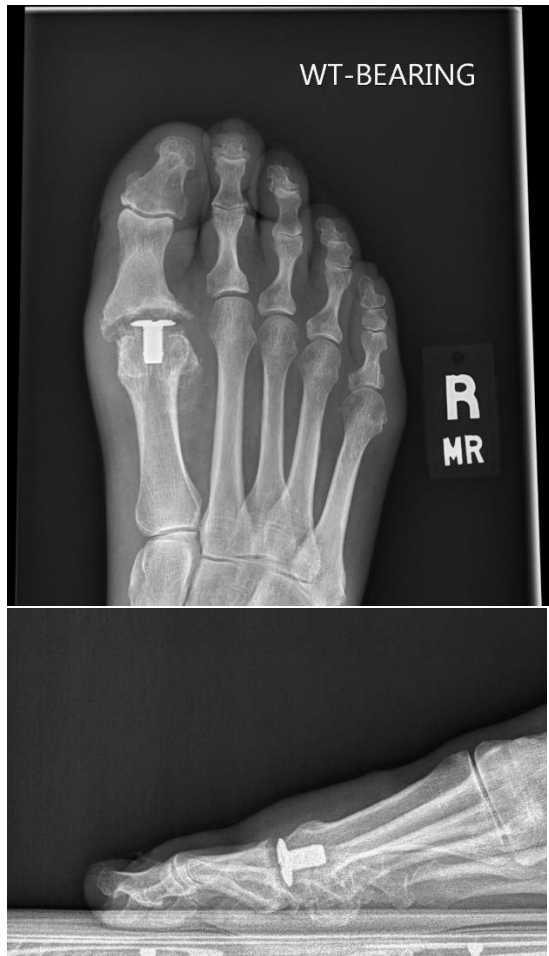
She was seen in the office again 3.5 months post op. She reported no pain, she had mild swelling and range of motion of 10 degrees of dorsiflexion and 25 degrees of plantar flexion. Images revealed a stable implant (Figure 6). She had returned to all desired activities without limitations. She acknowledged that she would both do the procedure again and recommend to a friend.

Figure 6: 3.5 month post-op images
